COMPREHENSIVE ASBESTOS SURVEY

**SUMMERVILLE FIRE & RESCUE STATION II
110 LUDEN DRIVE
SUMMERVILLE, SOUTH CAROLINA 29483**

**COMPREHENSIVE
ASBESTOS SURVEY**

Summerville Fire & Rescue Station II
110 Luden Drive
Summerville, SC 29483

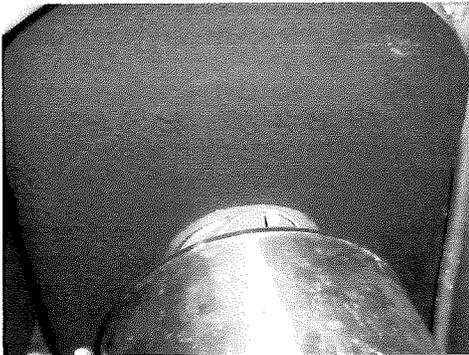
Asbestos fibers were identified in the Black Sink Coating. Approximately 6 square feet is present and is in good condition. This material is considered Category I – Non Friable Asbestos and is located in the kitchen.

**HOMOGENEOUS AREA 01
SINK COATING (BLACK)**

The identified asbestos containing building materials (ACBM's) to include the item(s) listed above. All removal work of the identified ACBM's should be performed by a properly trained and licensed abatement contractor prior to the planned renovation/demolition activities.

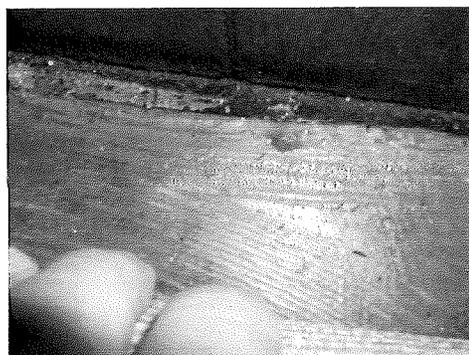
**HOMOGENEOUS AREA 05
CARPET GLUE**

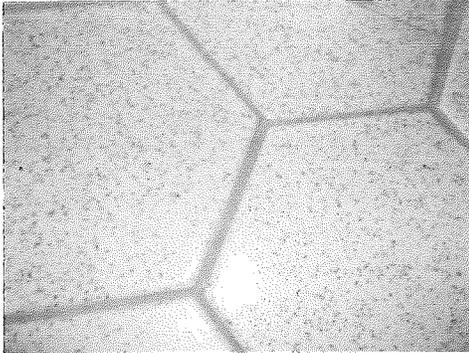
HOMOGENEOUS AREA 07
CERAMIC TILE GROUT
