**TOWN OF SUMMERVILLE
TREE PROTECTION BOARD – AGENDA
Summerville Municipal Complex
Council Chambers, Third Floor
July 6, 2020 - 9:00 AM**

STAFF REPORT
Tree Protection Committee Meeting
July 6, 2020

ISA Basic Tree Risk Assessment Form

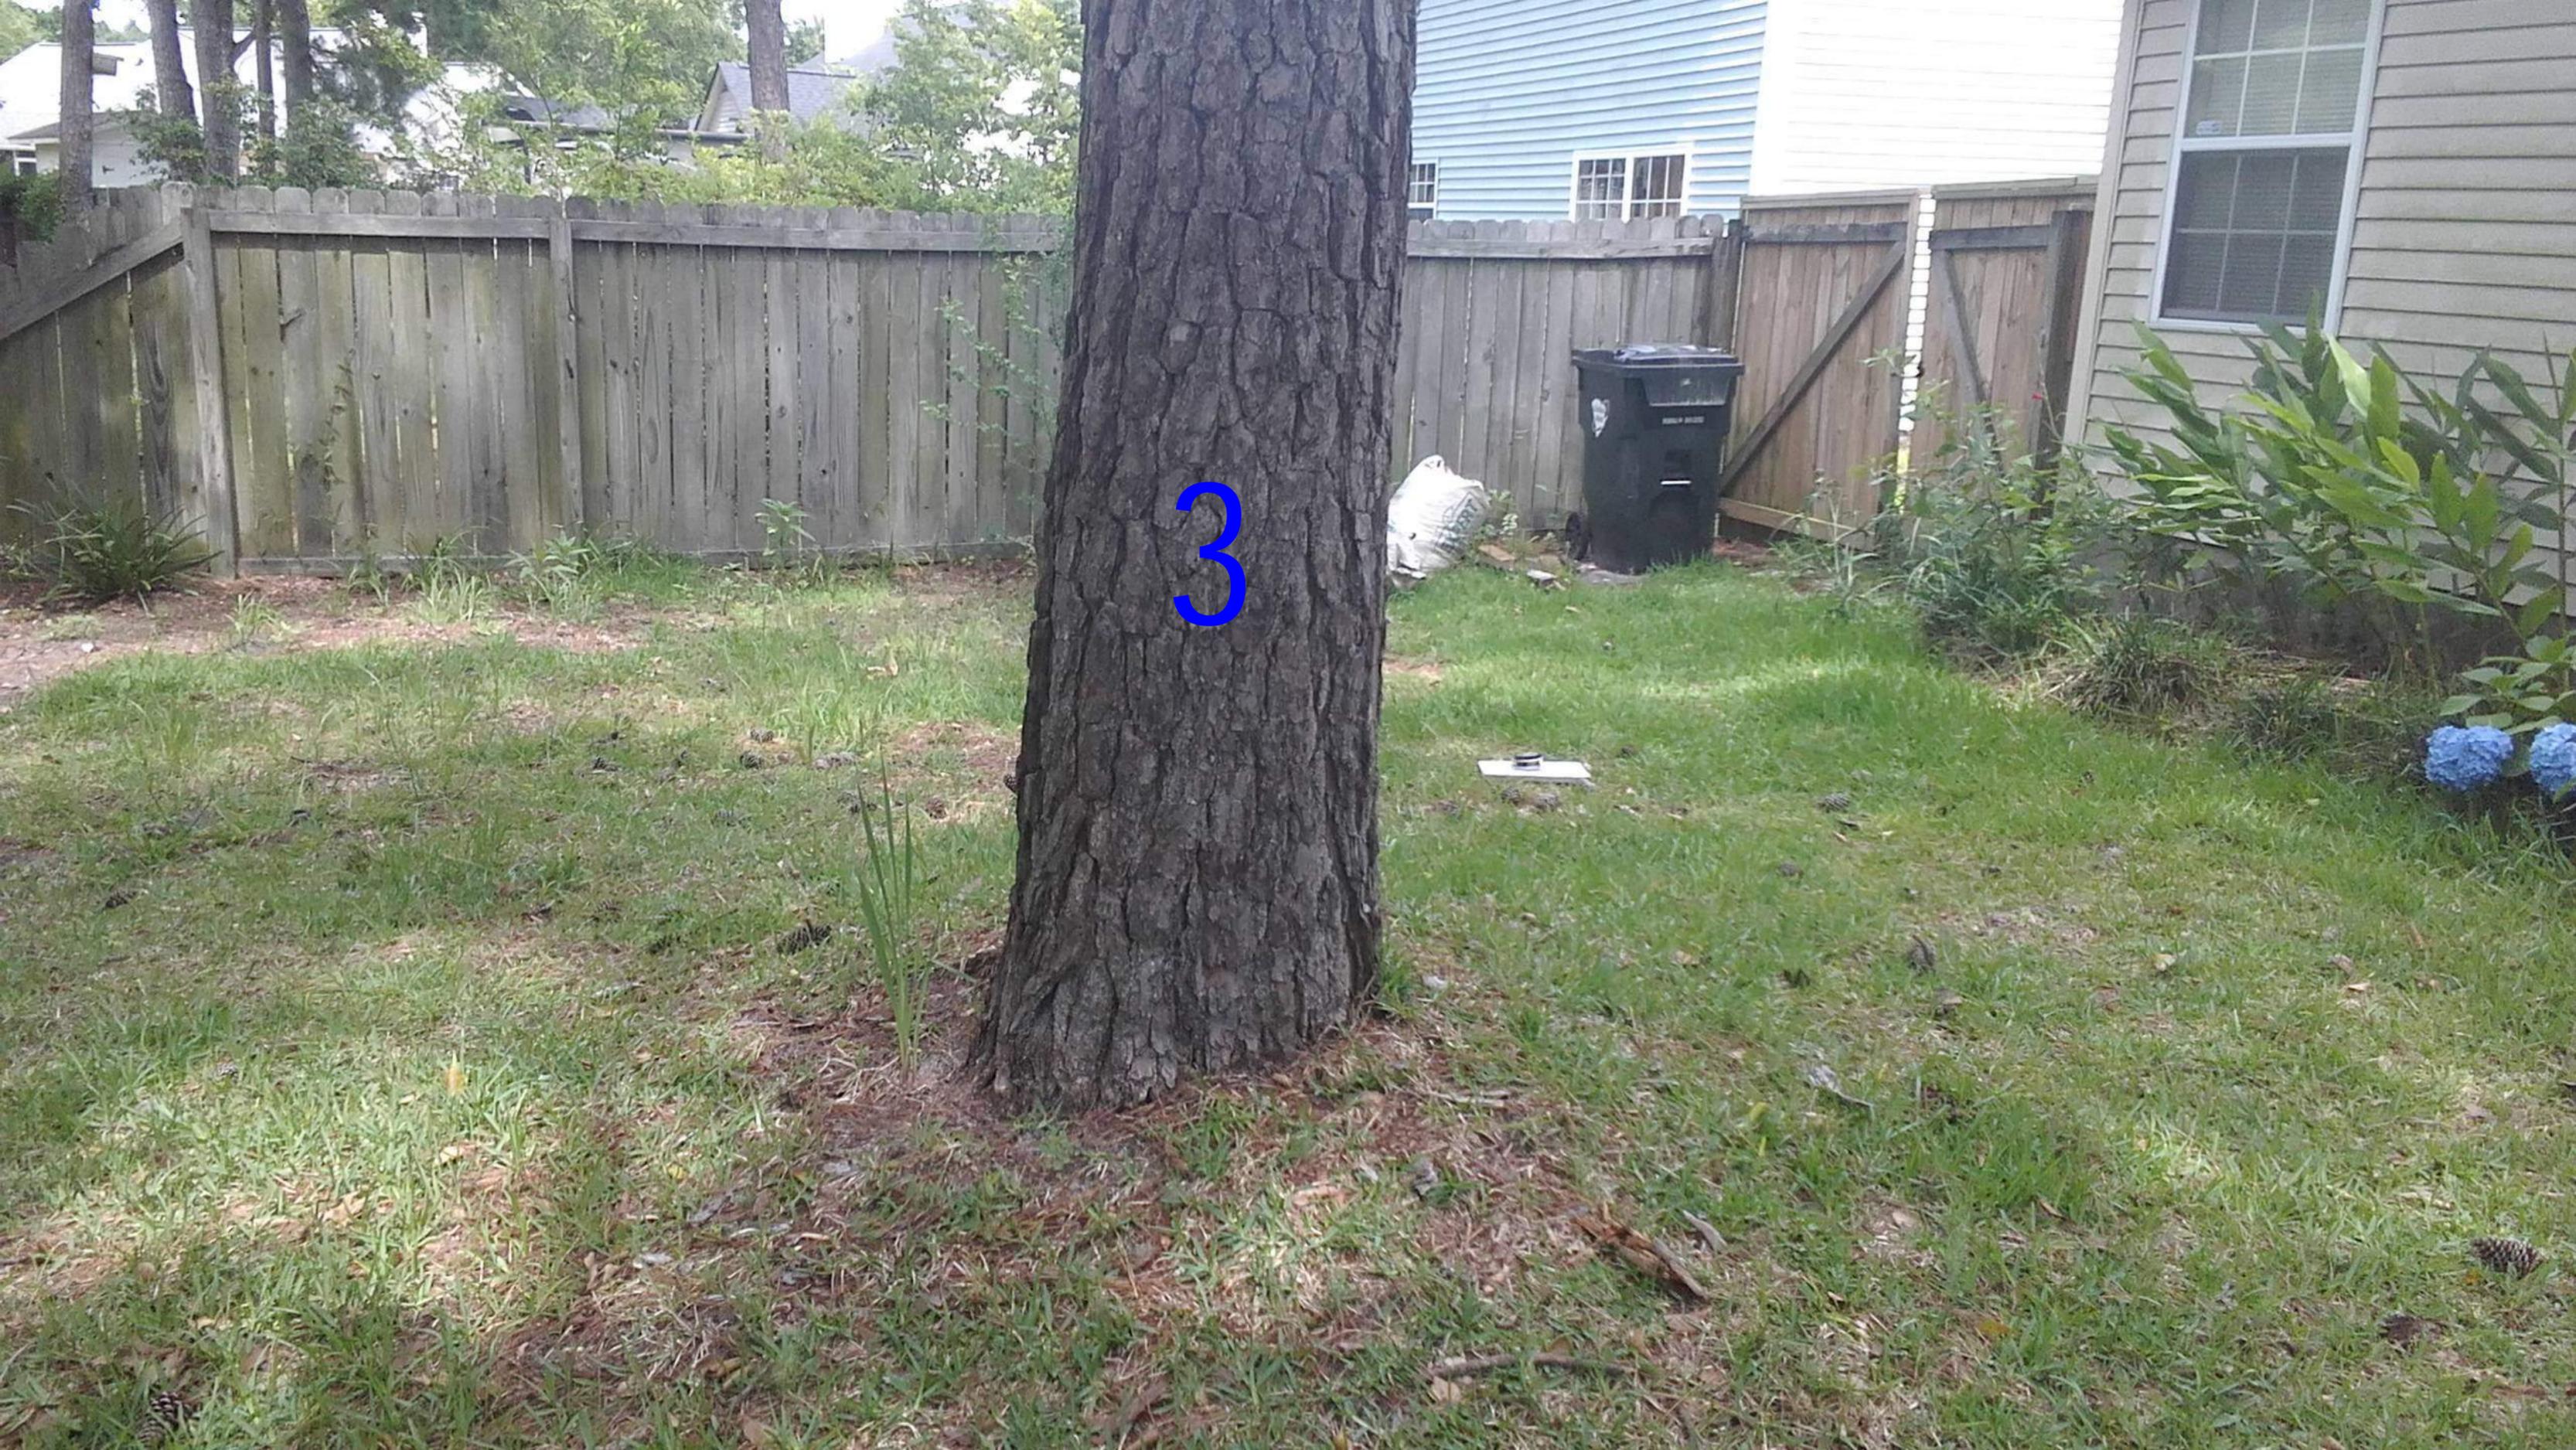
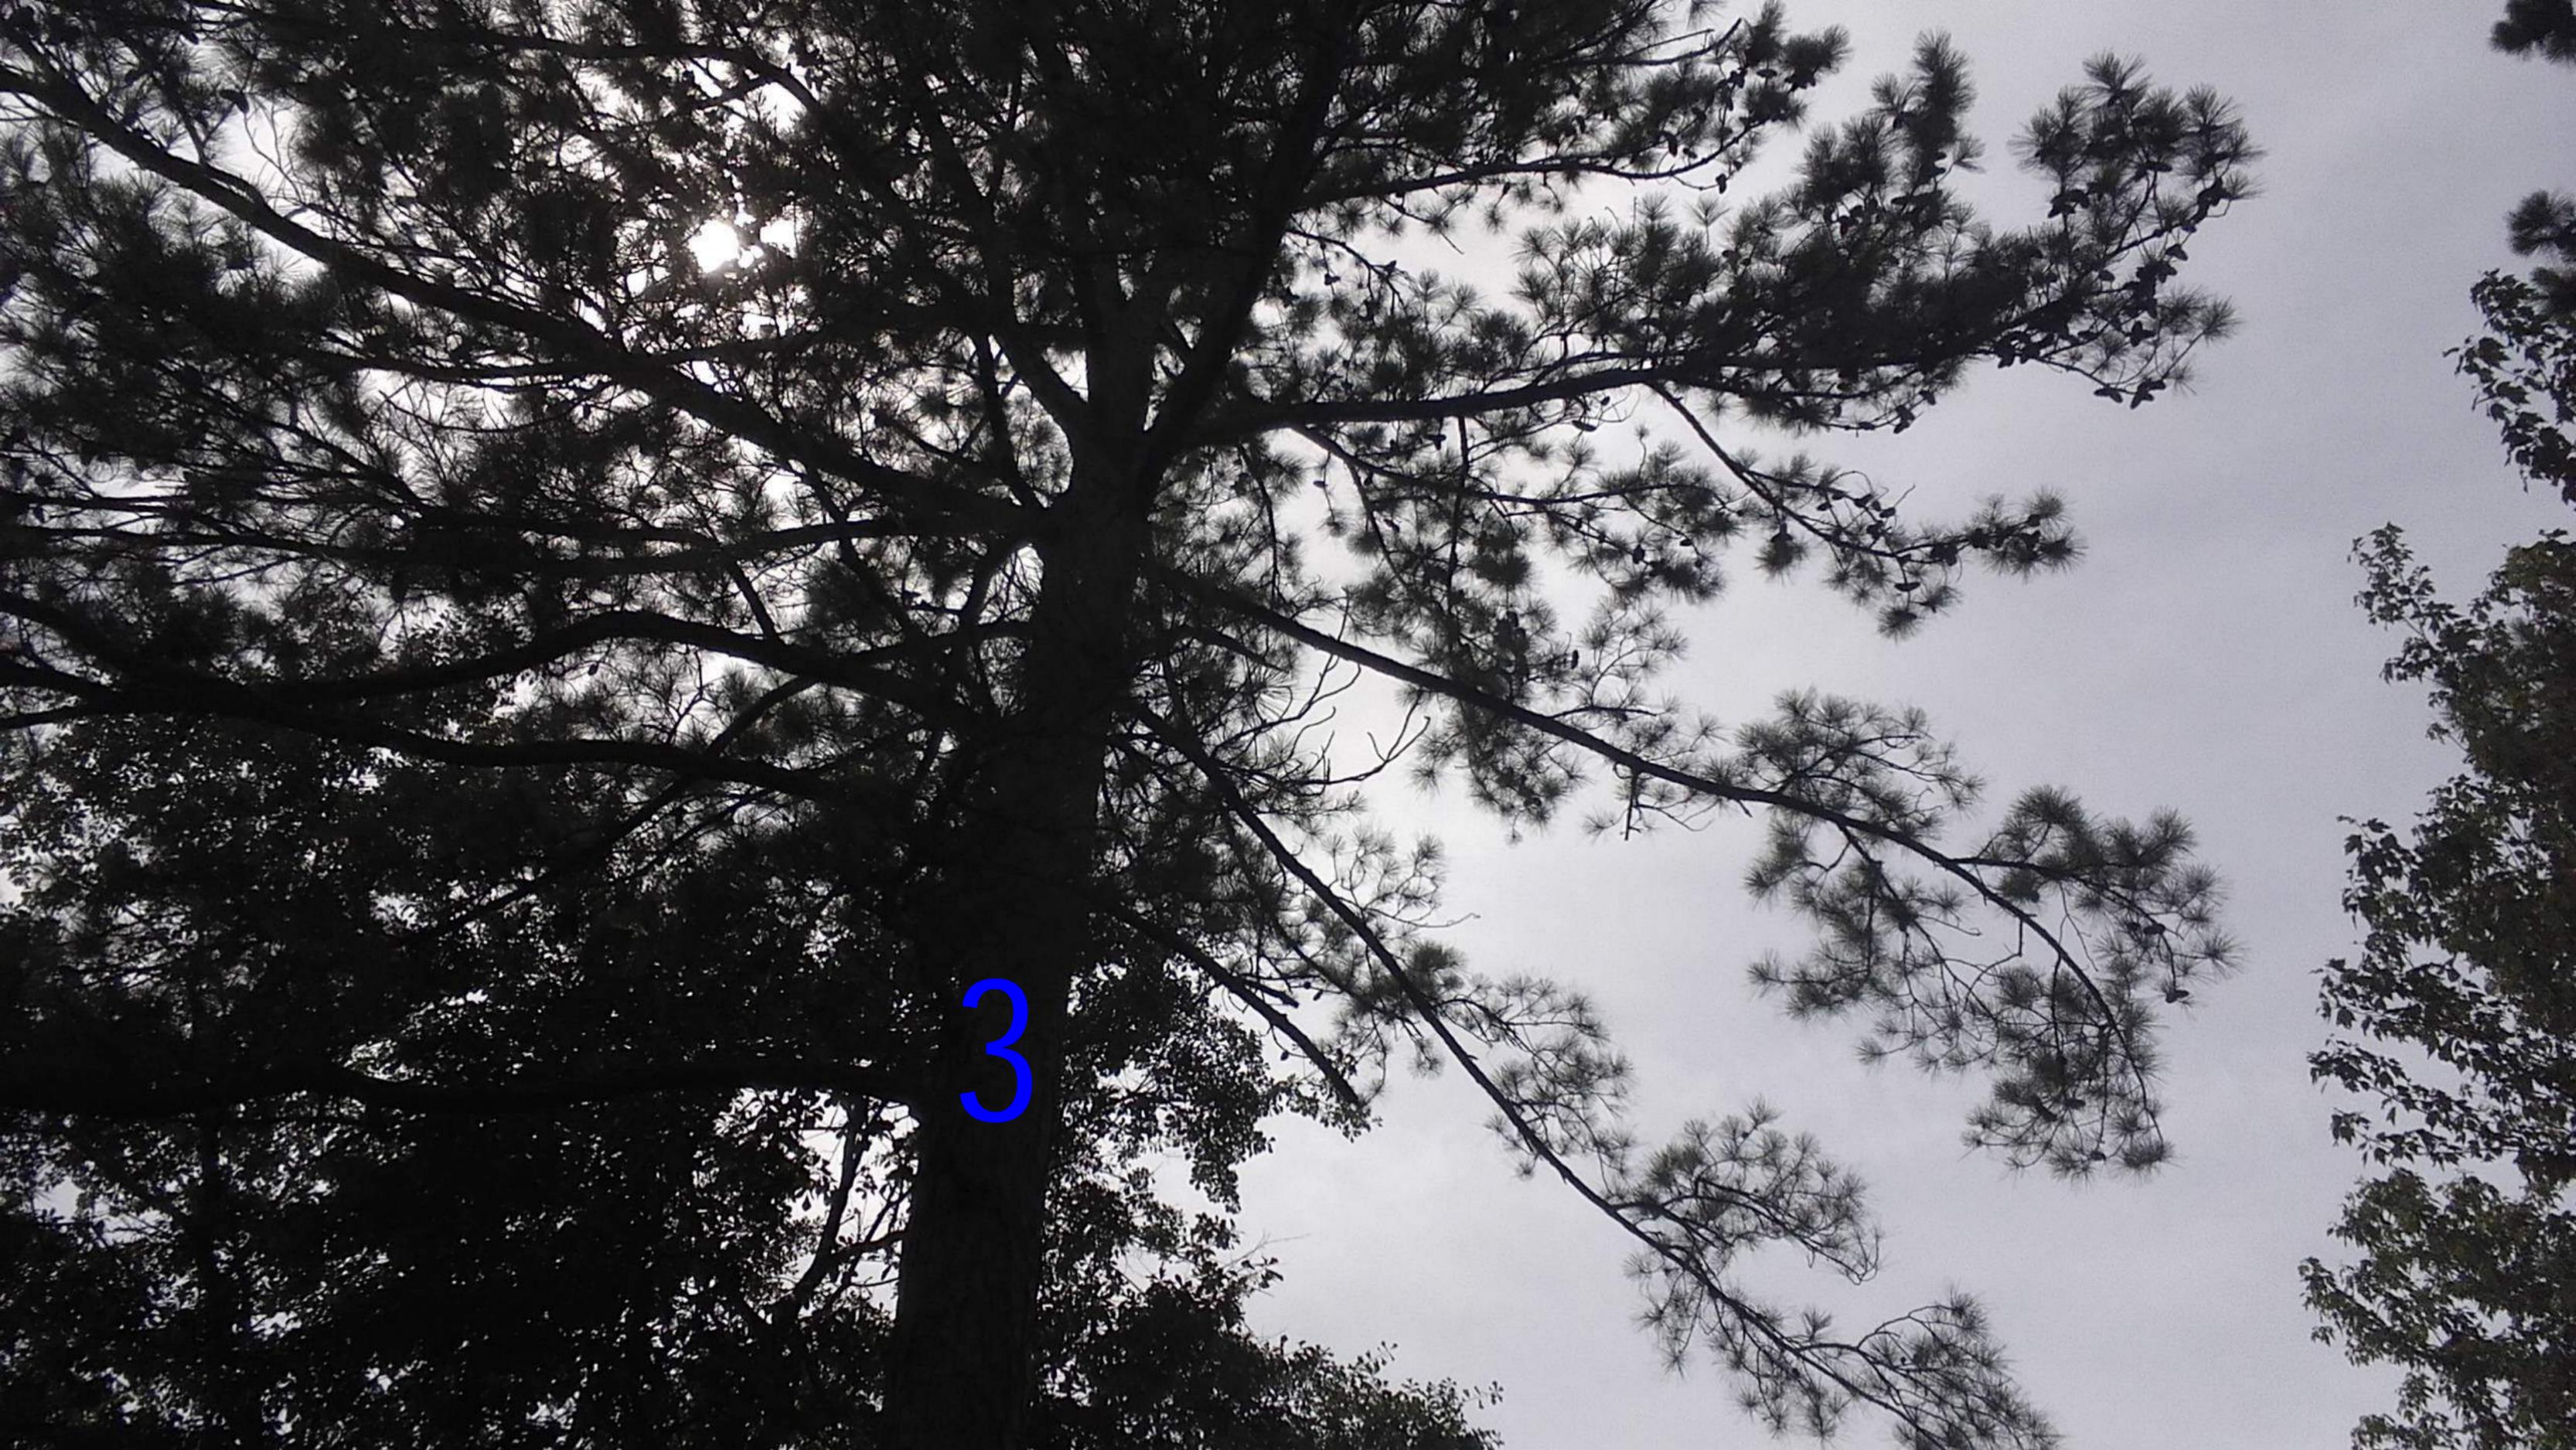
3

#3 – 21” cal. Tree located 14’ from house, is forked at the top

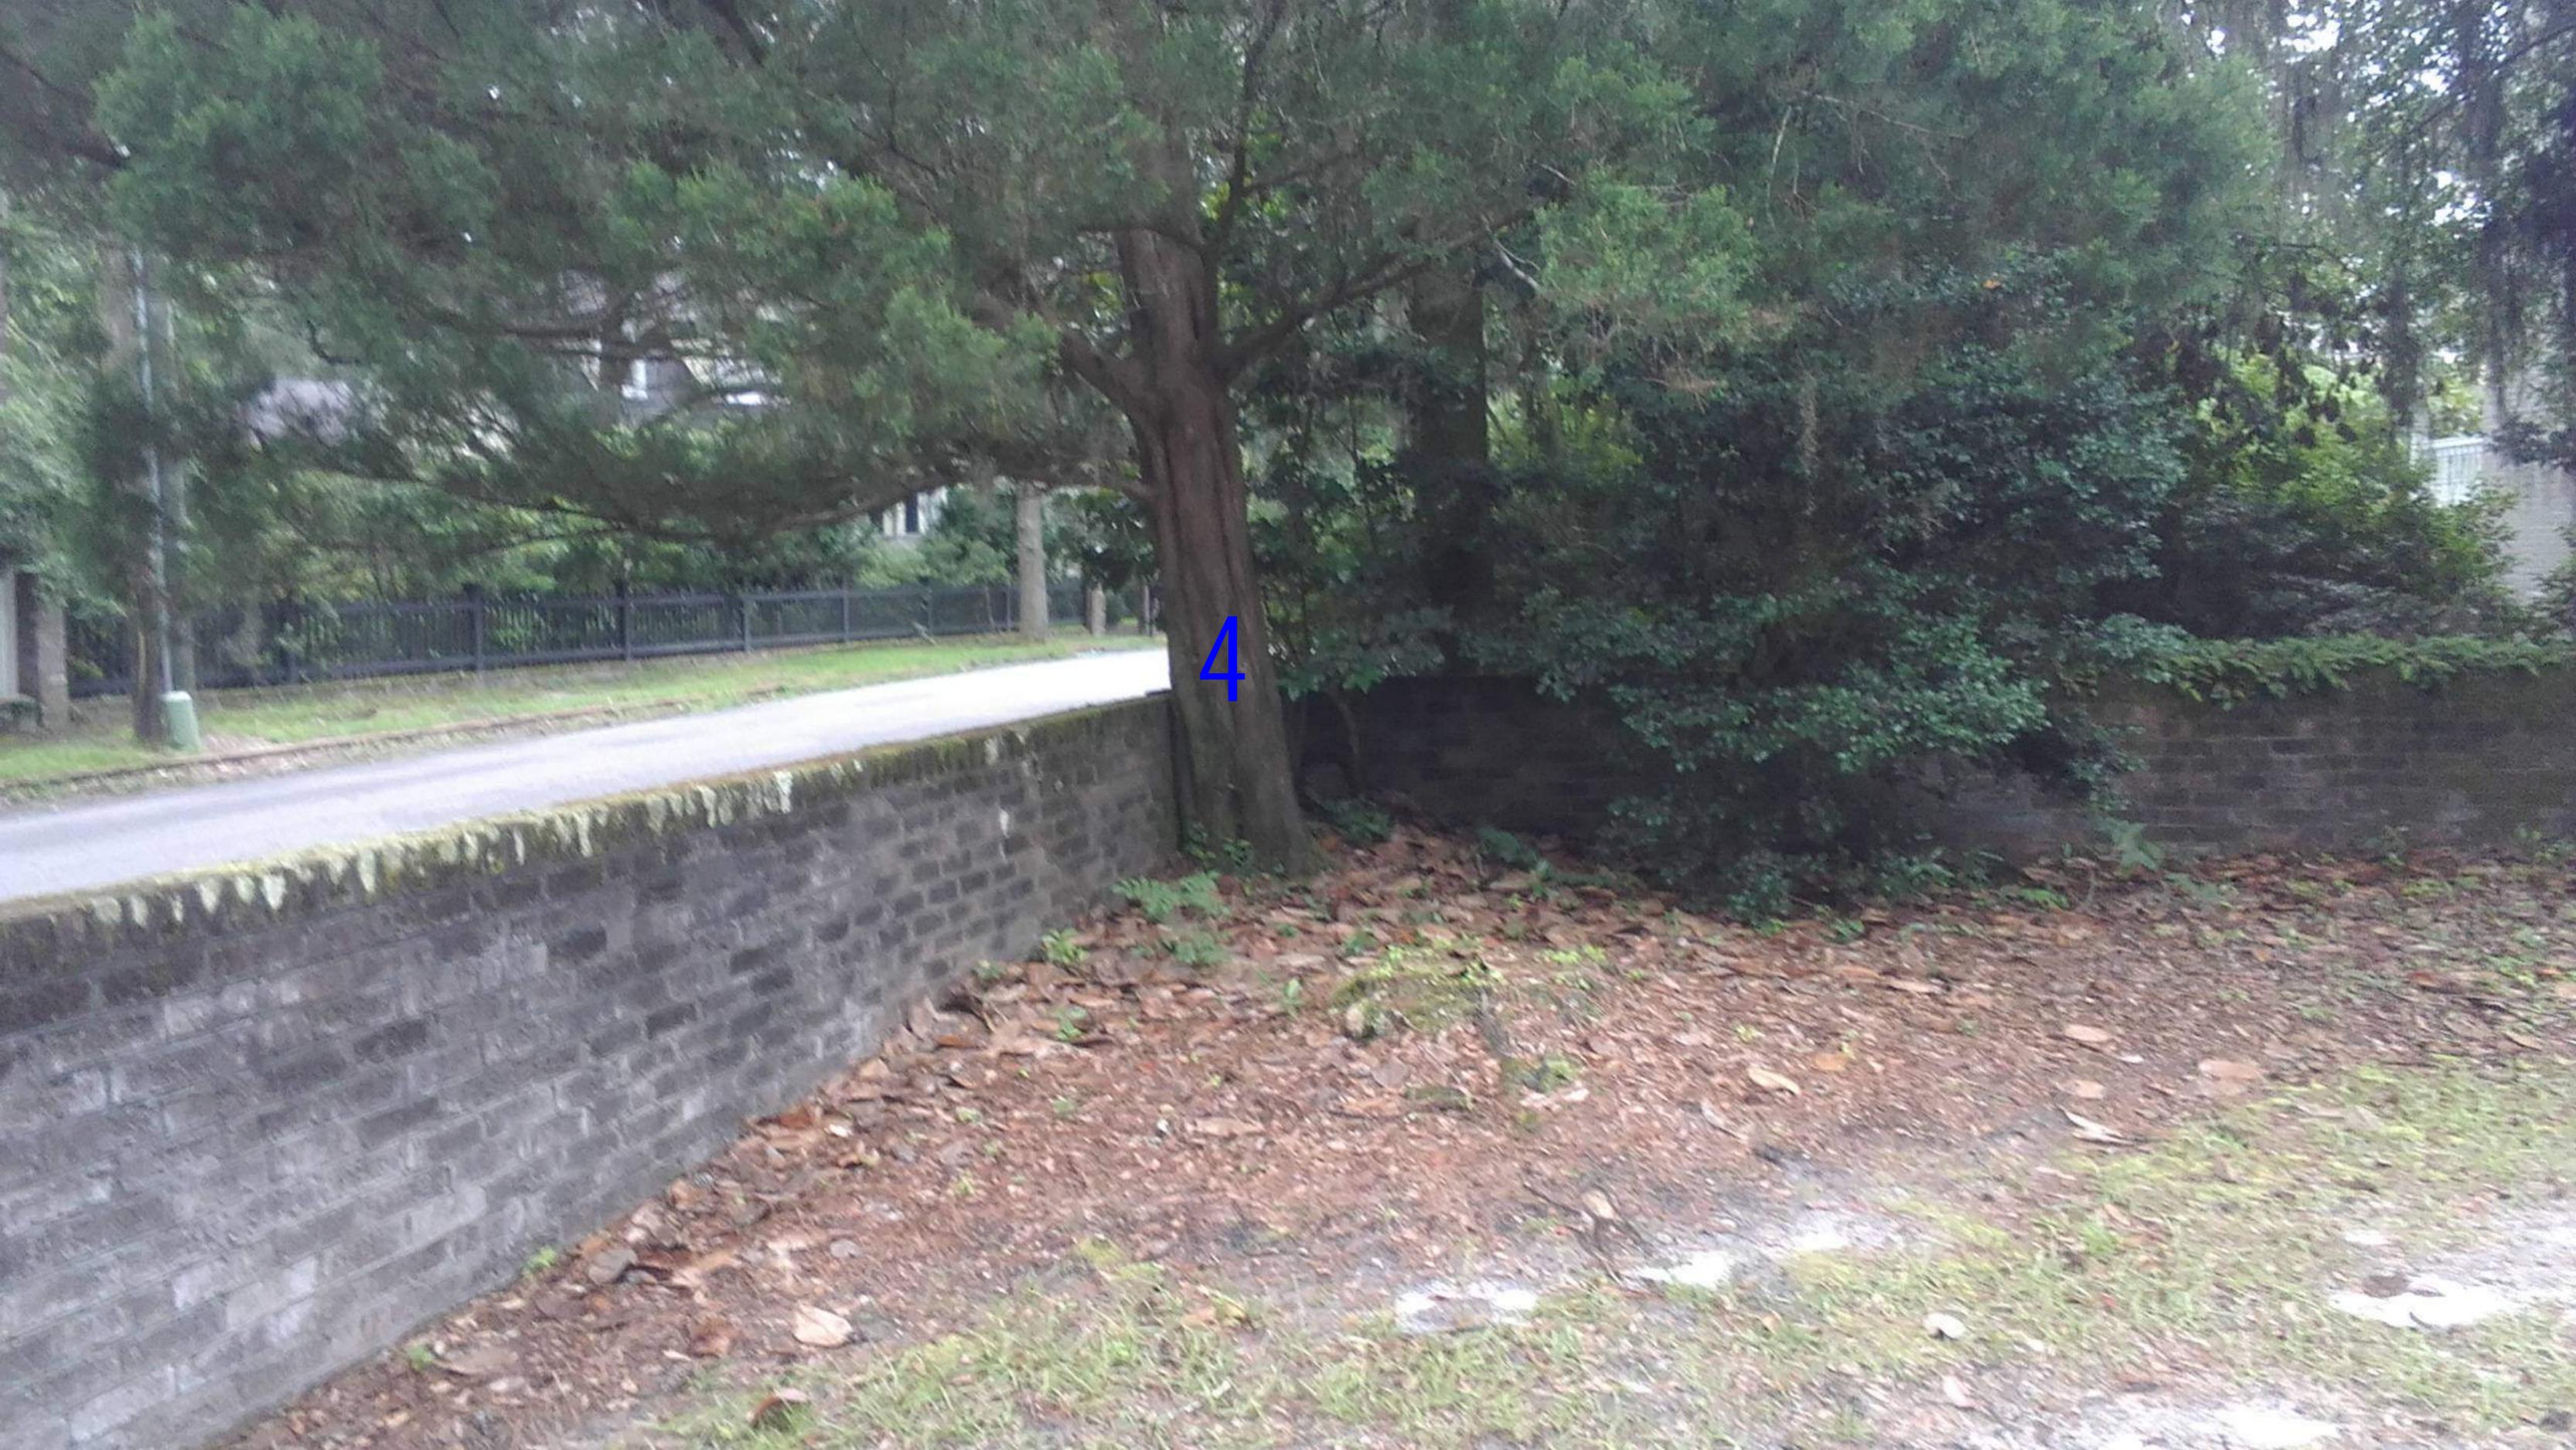
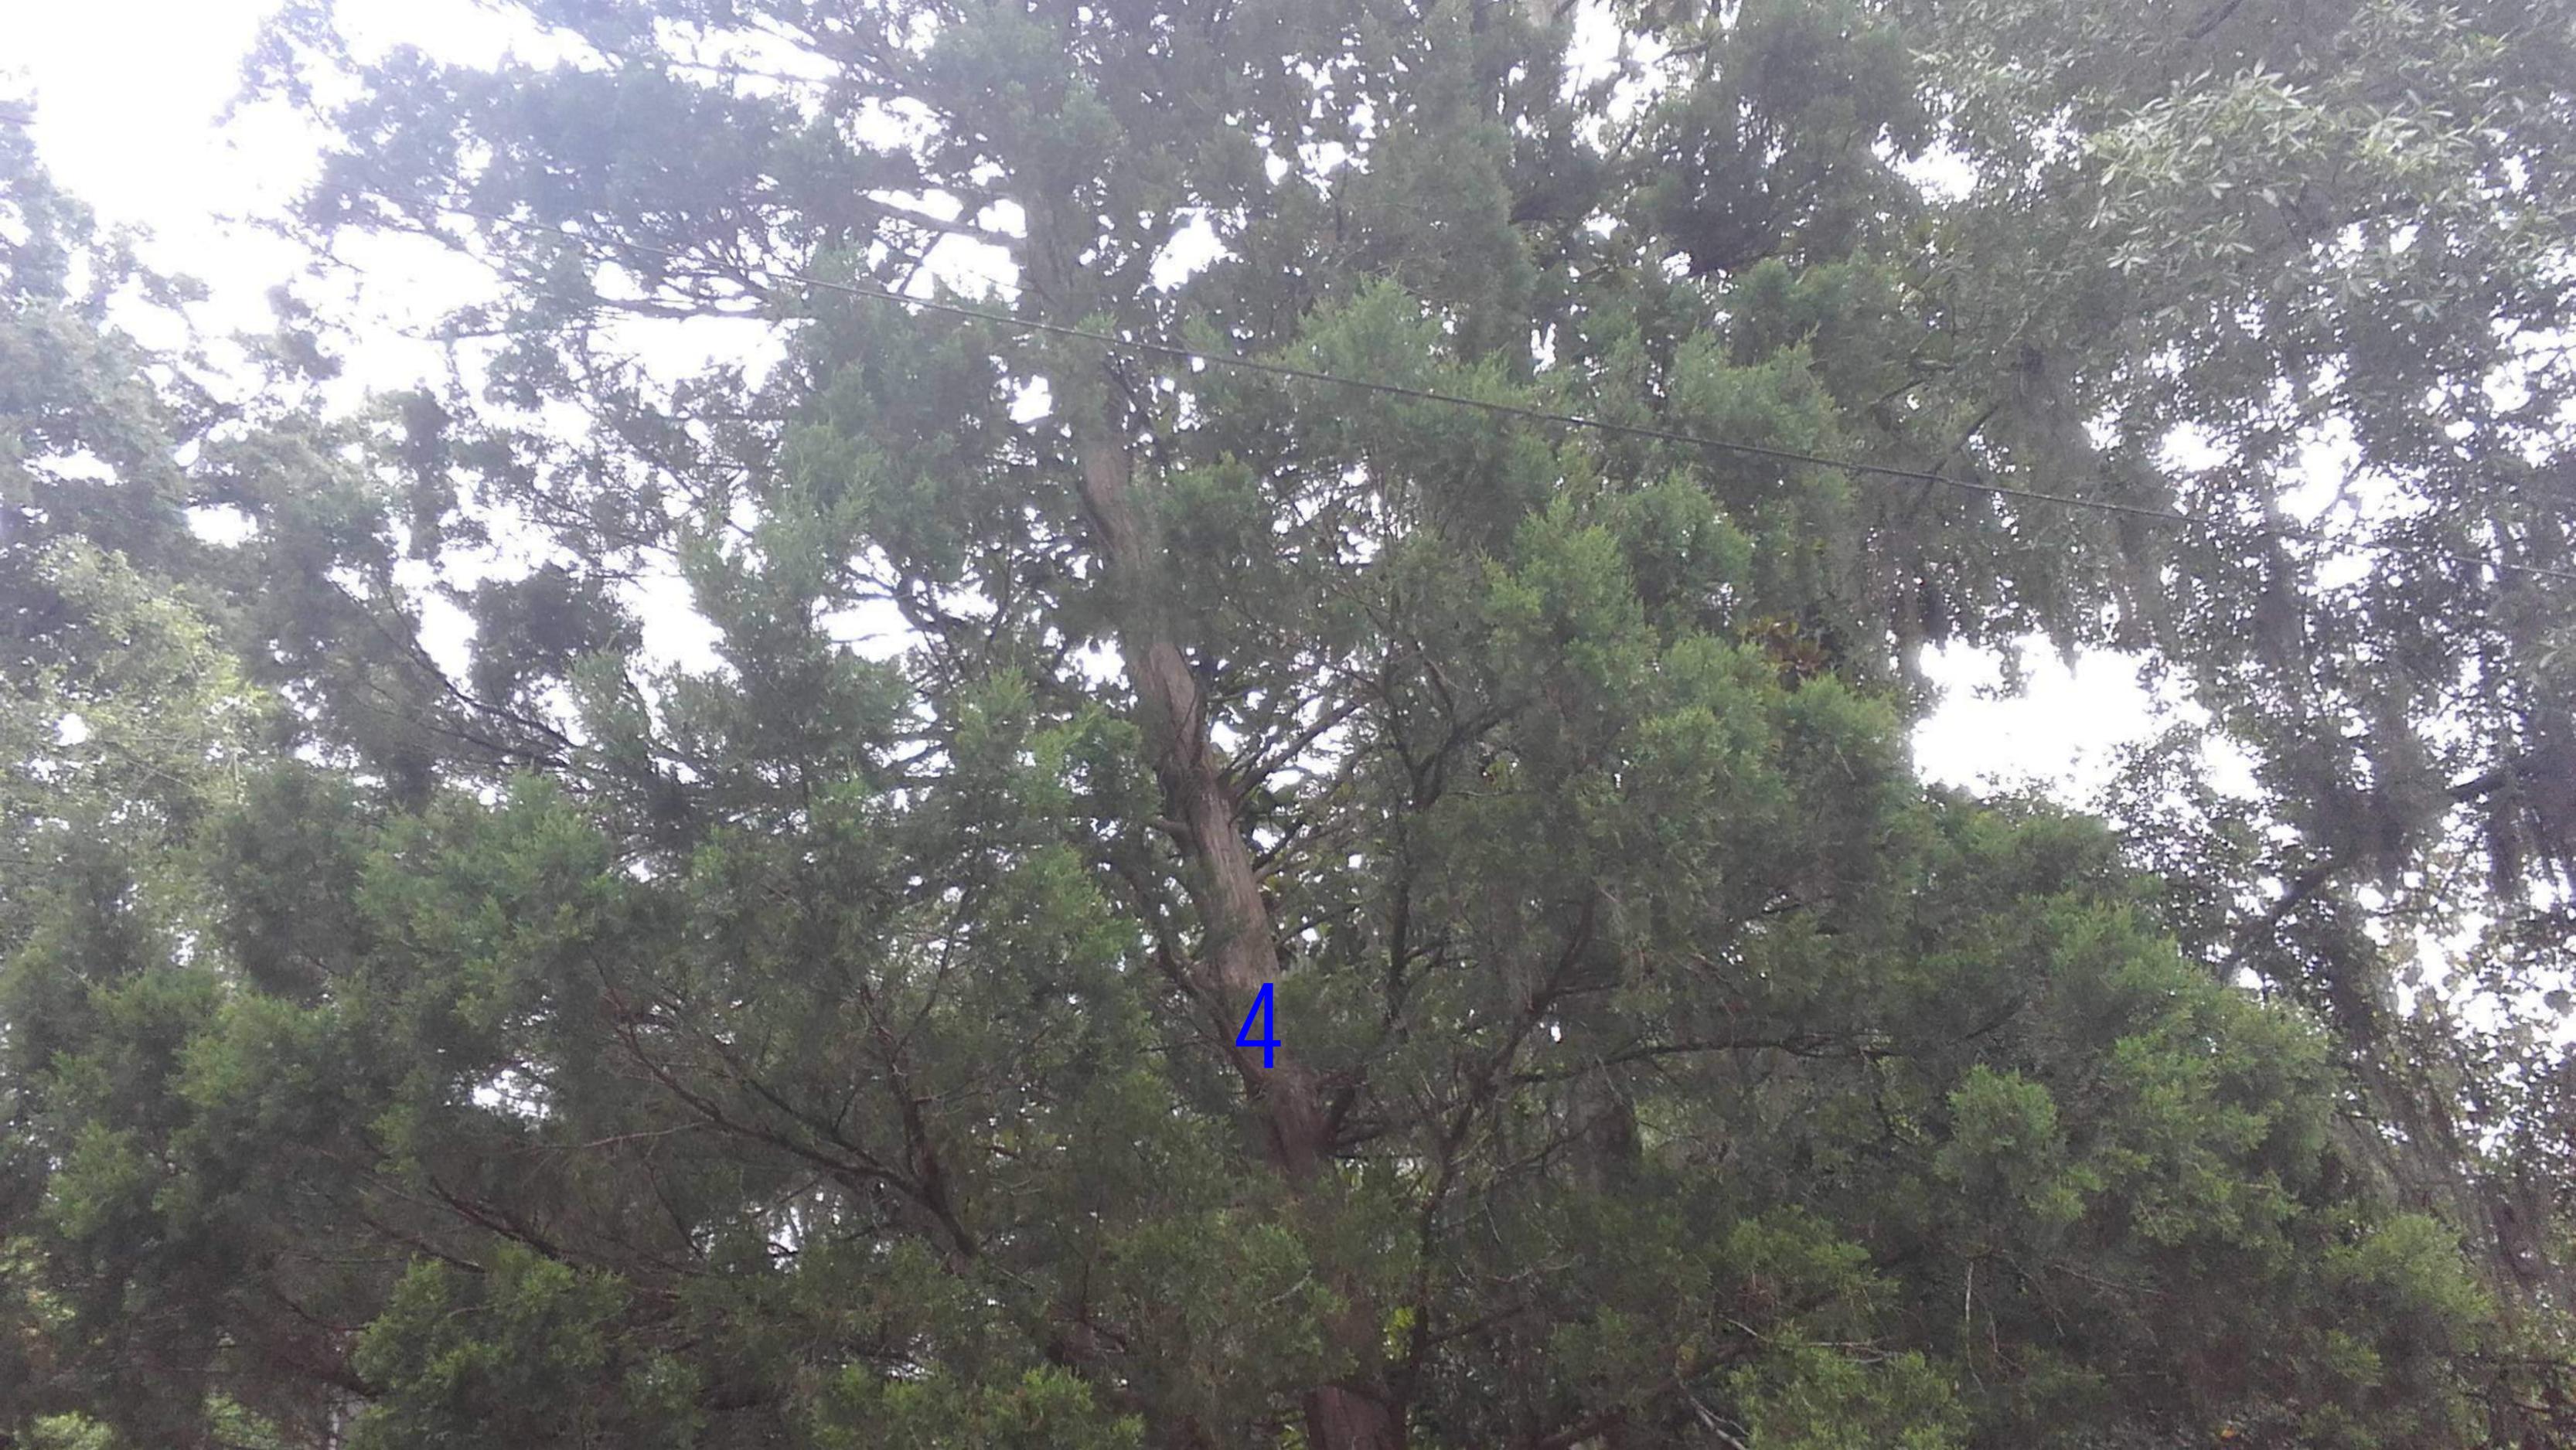
4

#4 – Cedar Tree – located next to brick fence, cause it to crack
